American Dream Home Inspection

SUMMARY REPORT

Inspection Address: 21 Quail Park Lane , Ladera Ranch, CA

Inspection Date: 6/27/2008 Start: 9:15 am End: 11:15 am

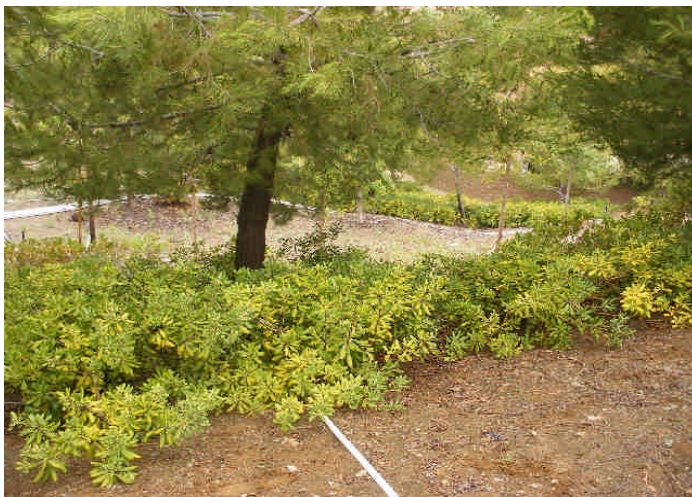
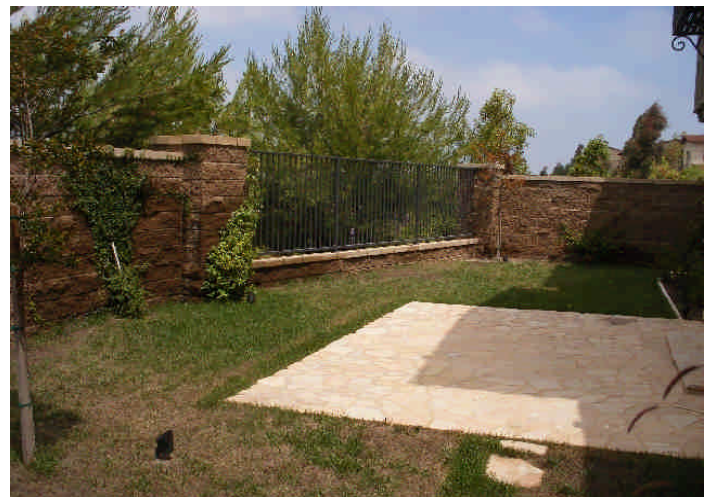
Because this is a hillside property, it should have a geological evaluation that should include an evaluation of other important and related issues such as grading and drainage. I do not conduct soils or geo-technical evaluations, nor am I qualified to do so. Since there is a slope behind this property, you may wish to consult with a geo-technical engineer before close of escrow.

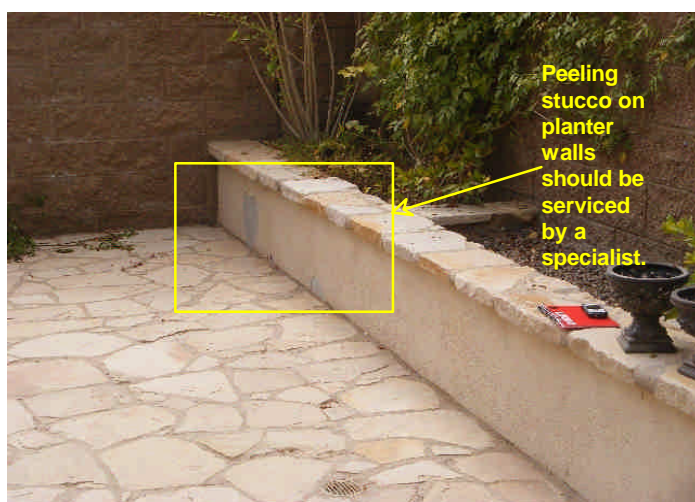
The stucco paint is peeling in places, as a result of inadequate bonding or preparation, the section on the planter wall should be serviced by a specialist.

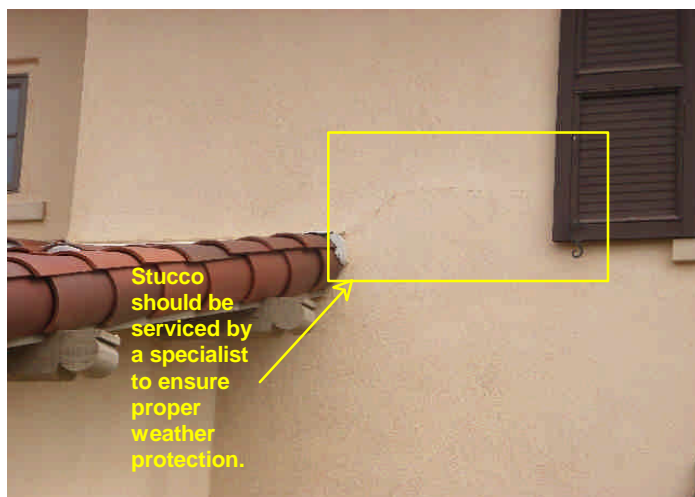
The cracks in stucco should be serviced by a licensed specialist to ensure proper weather protection and to prevent moisture intrusion damage to residence.

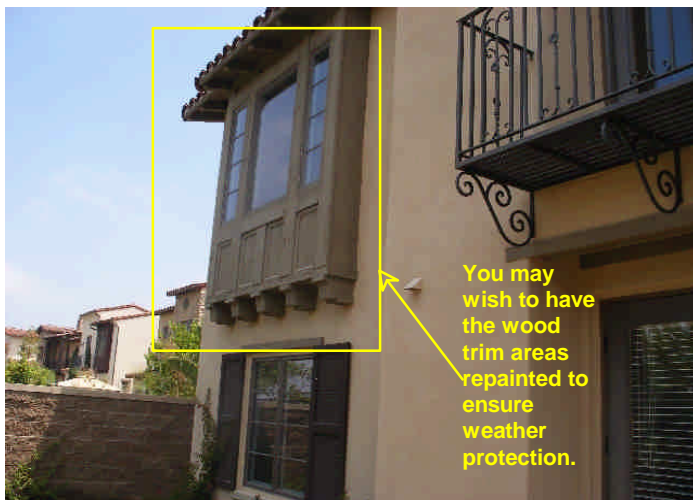
The wood components including trim should be repainted to ensure proper weather protection. A licensed specialist or painter should repaint areas that are peeling and need maintenance.

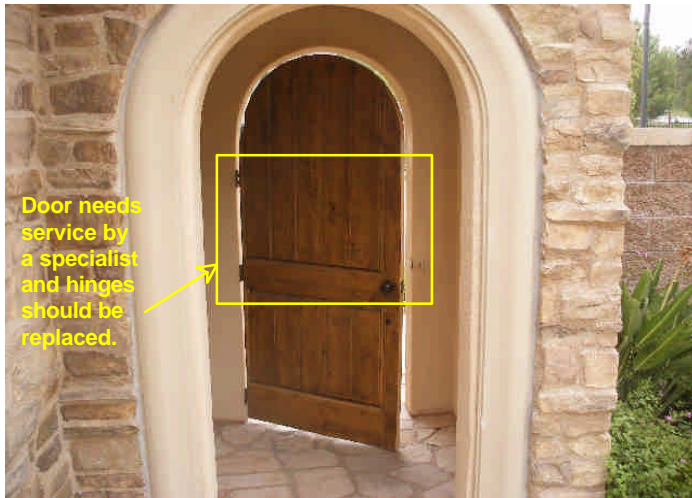
The exterior front door is damaged and should be serviced or replaced by a specialist. The door is damaged near the hinges, does not open and close easily and should be serviced by a specialist. The hinges will also need to be replaced with a functional type designed for outside doors.

Door needs service by a specialist and hinges should be replaced.

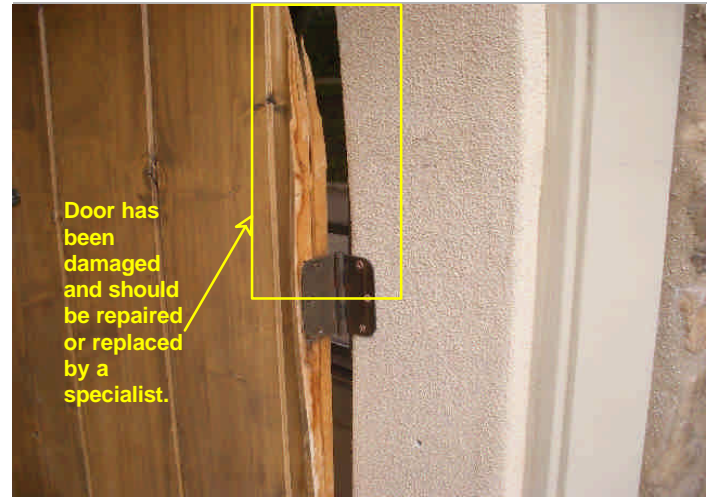
Door has been damaged and should be repaired or replaced by a specialist.

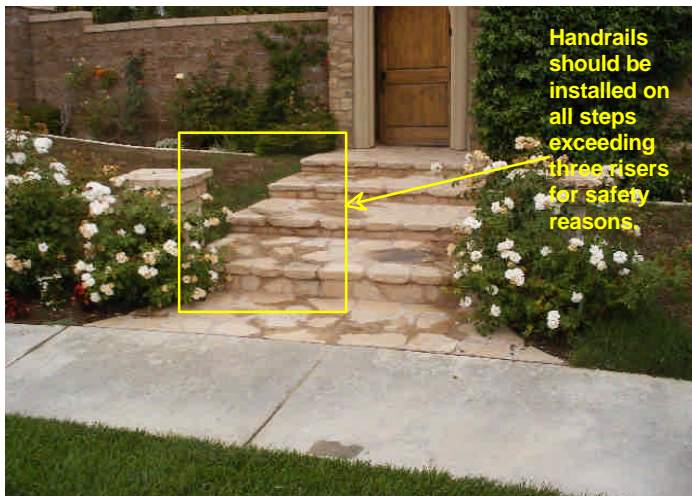
Handrails should be installed on all steps exceeding three risers for safety reasons.

As a safety precaution, we recommend installing handrails on steps that have three or more risers, and particularly if children or the elderly visit or occupy the property.

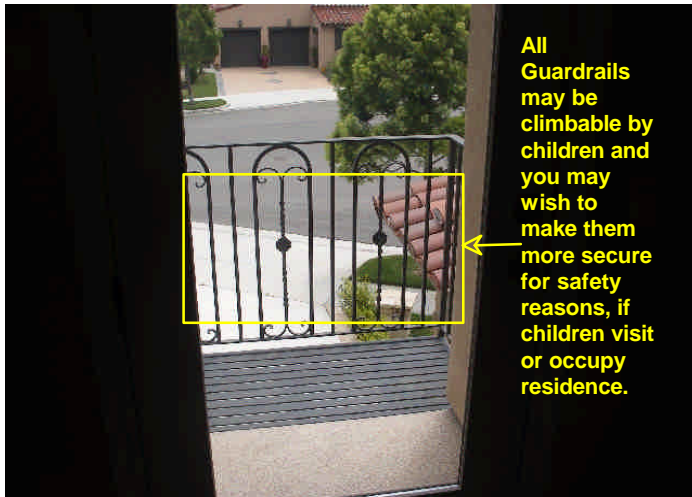
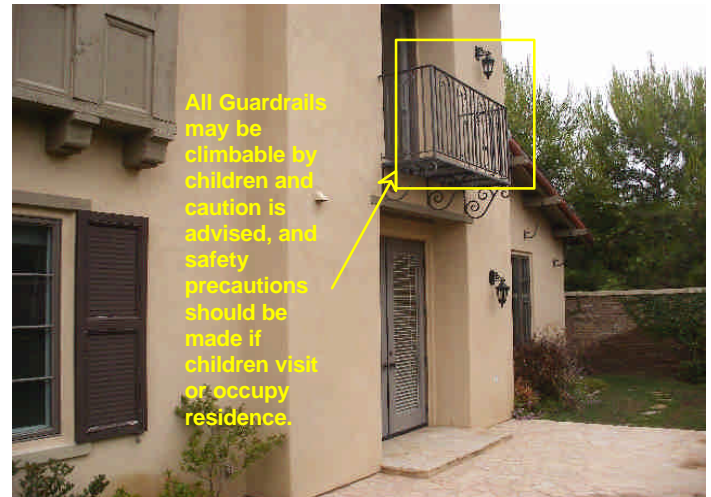
The balcony guardrails may be climbable, and therefore not child-safe. If children occupy or visit this property appropriate precautions should be taken to make the area more secure.

The balcony guardrails may be climbable and therefore not child-safe - *Continued*

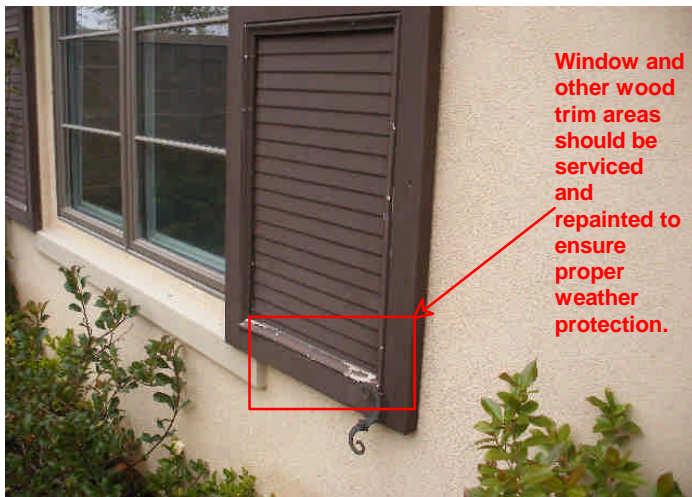
The window-trim needs maintenance-type service and repainting to ensure proper weather protection. You may wish to have a licensed specialist or painter, paint sections of the residence that possess peeling paint.

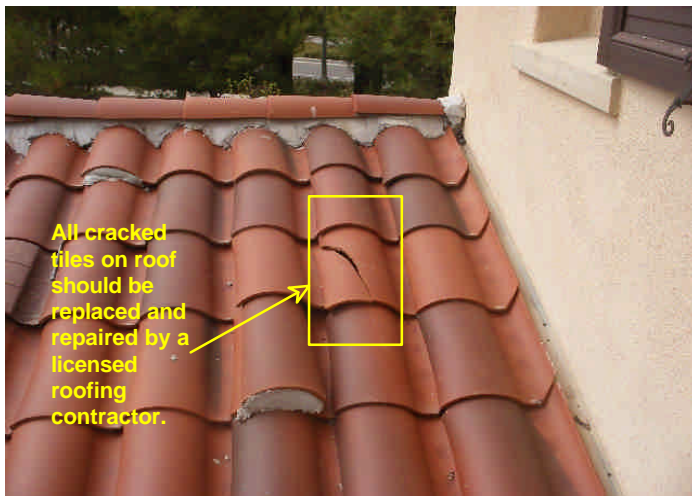
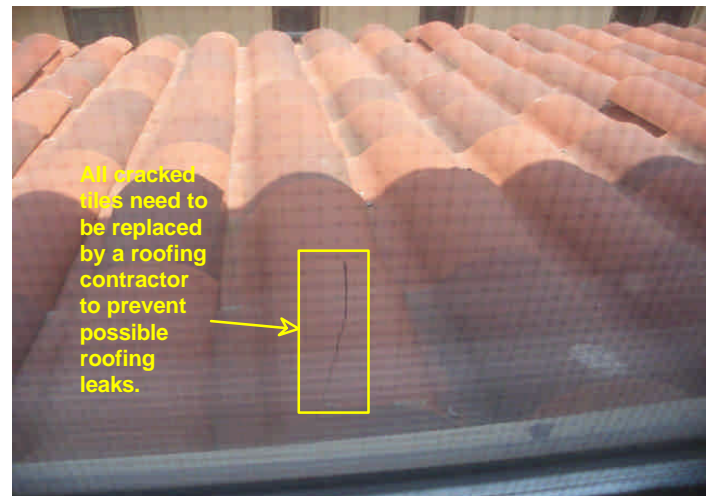
There are a number of cracked or broken tiles that should be serviced by a licensed roofing contractor to ensure the roof does not leak, these repairs should be completed before close of escrow. My service does not guarantee this roof will not leak, and a water test performed by a licensed roofing contractor with a roofing certification issued is recommended.

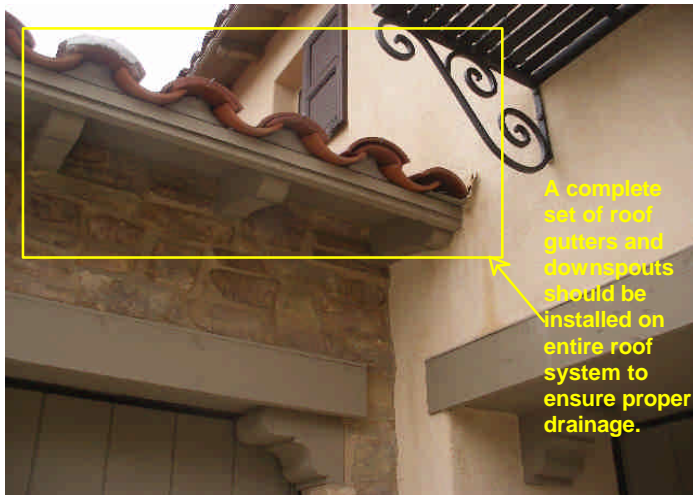
There are no gutters on the residence, which are recommended for the general welfare of the residence and its foundation, inasmuch as moisture is a perennial problem. A complete system of roof gutters and downspouts should be installed by a specialist before close of escrow.

There are no gutters on the residence which should be installed by a specialist to ensure proper drainage - *Continued*

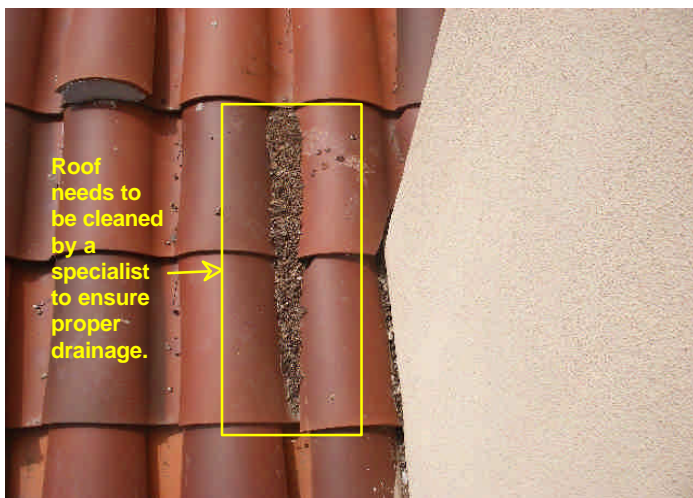
The roof needs to be cleaned to ensure proper drainage to prevent roof leaks. There may be bird droppings or other trapped leaves on rooftop that should be cleared.

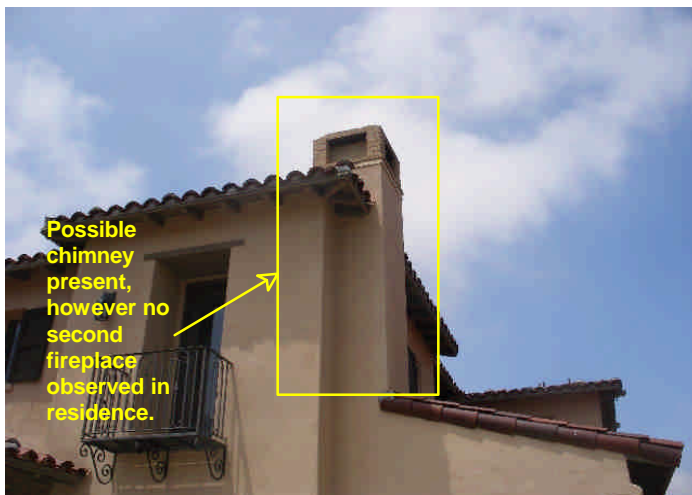
The chimney walls appear to be in acceptable condition. Near the front of the residence, a possible chimney wall appeared present, however a second fireplace was not observed on the property, or in the room upstairs with the front yard balcony. If a second fireplace was present on the property, the previous owner may have filled in the fireplace area or removed it. You may wish to consult with the sellers or a fireplace specialist, if this is not an architectural design element.

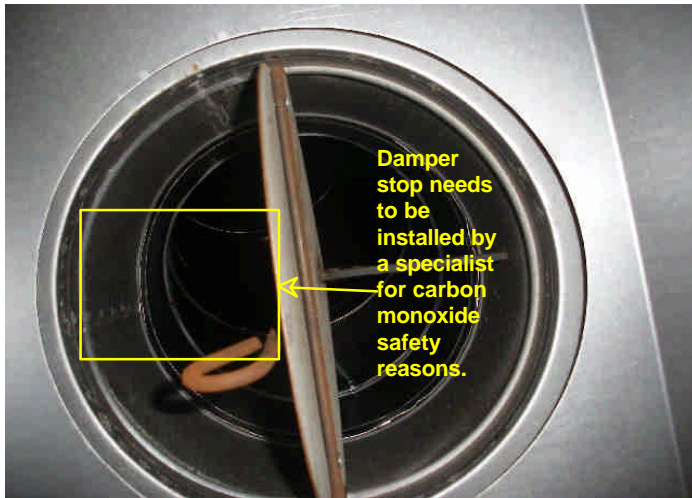
A damper-stop should be added as a safety feature of the ornamental fire, which prevents it from being fully closed for carbon monoxide safety reasons.

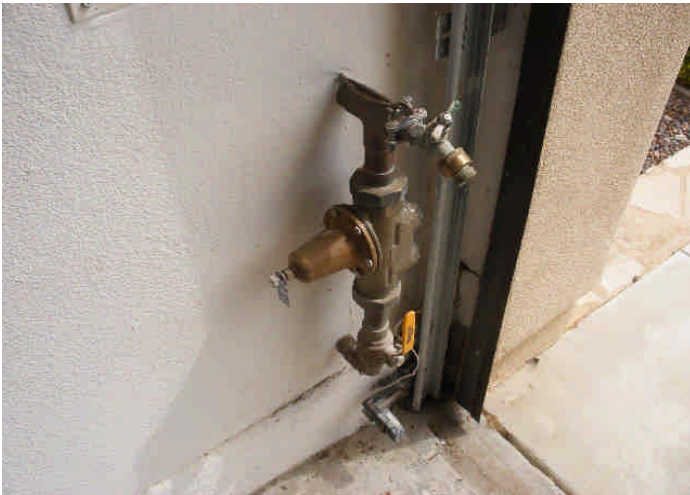
A pressure regulator is present on system but water pressure needs to be checked by a plumber, since a fire suppression sprinkler system is present. Both supplies of water pressure should be checked and verified as functional and at a safe level to ensure leaks and damage to piping system will not occur.

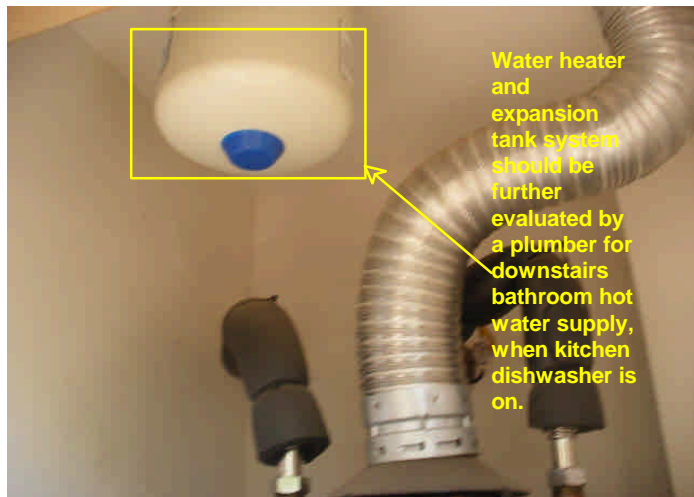
The hot water heater, expansion tank and circulating pump are not functional for downstairs bathrooms and should be serviced and further evaluated by a licensed plumber. However, the components of circulating systems have a shorter design-life than many other components. There was no functional hot water present in the downstairs bathrooms, including the sink and tubs when the dishwasher in the kitchen was left on. Based on the size of the water heater, hot water should be functional in all bathrooms when the dishwasher is on. A licensed plumber should further evaluate and service this condition before close of escrow. Functional Hot water is required in all bathrooms per the Uniform Housing Code ordinances.

The water heater and expansion tank and pump need to be serviced by a plumber due to hot water supply - *Continued*

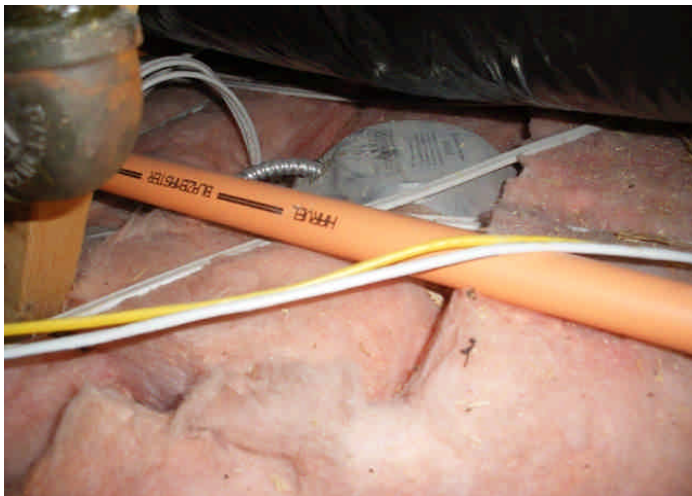
The residence is equipped with fire sprinklers, which we are not qualified to evaluate and specifically disclaim in our contract. Several brands however, such as Omega, Central, Star, and Gem, have been alleged to be defective and subject to litigation or voluntary recall. Therefore, you may wish to have the system evaluated by a fire sprinkler contractor and certified as being functional.

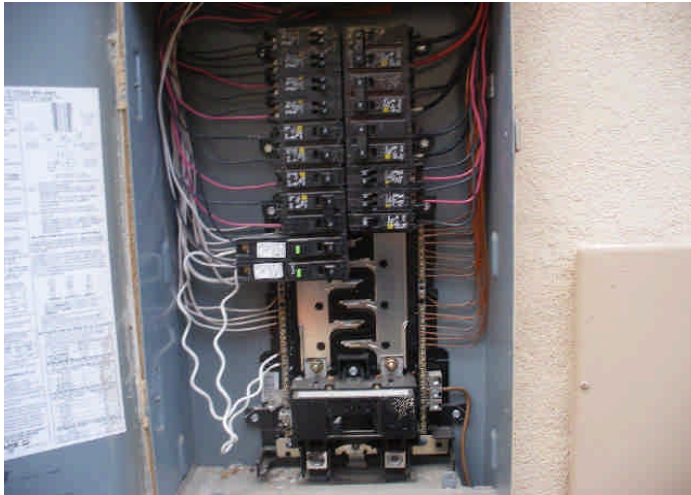
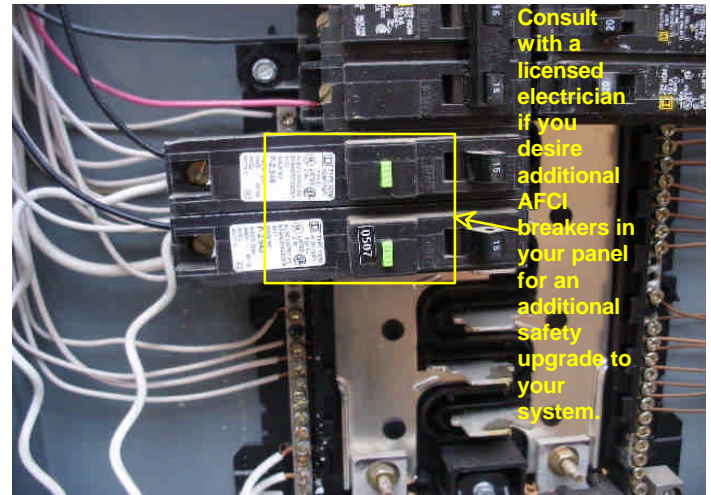
There are no visible deficiencies with the circuit breakers and AFCI breakers installed for bedroom circuits as required for this year construction. You may wish to consult with a licensed electrician if you desire additional AFCI (arc fault circuit interrupter breakers) installed in your panel. The 2005 National Electrical Code mandated combination arc-fault circuit interrupters, abbreviated as (AFCIs) for all 120-V, 15- and 20-A branch circuits that supply bedroom outlets in new homes starting January 1, 2008, which generally includes receptacle outlets, lighting outlets and smoke alarm outlets. The 2008 NEC expands the requirements for combination AFCIs beyond bedroom circuits to include other areas in a home, such as family rooms, dining rooms, living rooms, closets and hallways. You should consult with a licensed electrician regarding this electrical safety upgrade before close of escrow.

There are no visible deficiencies with the circuit breakers - *Continued*

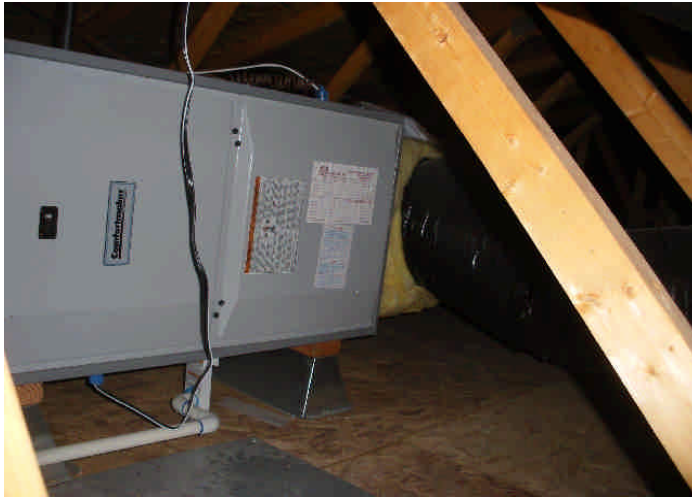
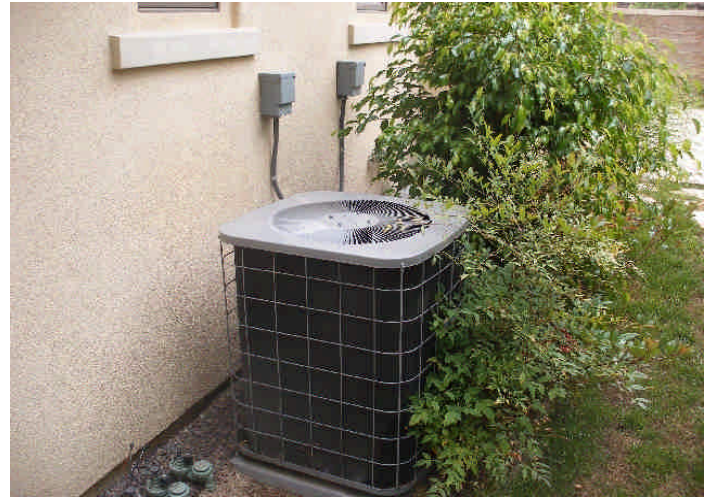
Central heat and air-conditioning are provided by dual systems, consisting of two approximately 4 year-old Comfortmaker furnaces with evaporator coils that are located in the attic area , and two approximately 4 year-old condensing coils that are located in side yard.

The residence is served by dual systems with the types and locations indicated within the report - *Continued*

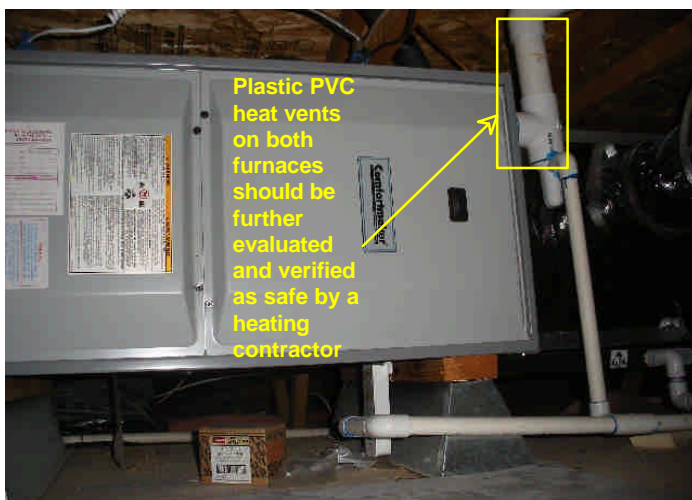
The vent pipes are a high-temperature, PVC, type that has been known to crack and split, and particularly at the connections, which could allow the bi-products of combustion to contaminate the residence. Some of these may be identified by the brand name Plexvent, Plexvent II, or Ultravent. There is no evidence of any damage at this time, but it should be monitored, and you may wish to have a specialist evaluate it. For additional safety, carbon monoxide detectors and smoke alarms should be installed in the attic area, and carbon monoxide detectors installed on each floor of the residence for additional safety.

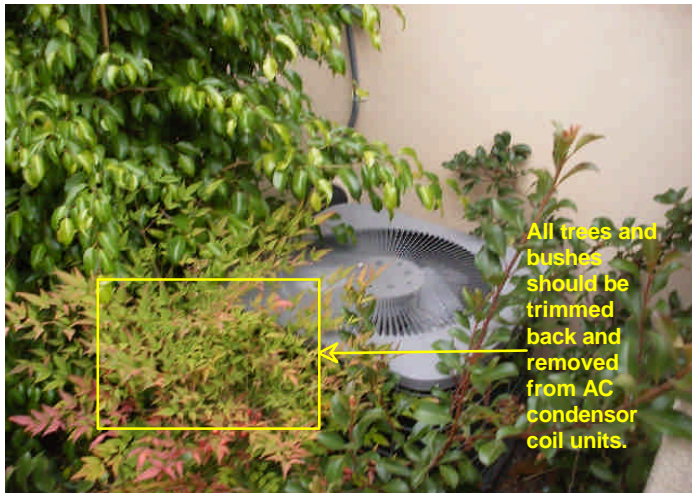
The vegetation should be trimmed away from the AC condensing coils for maintenance reasons. All trees and bushes should be trimmed back away from the units and maintained.

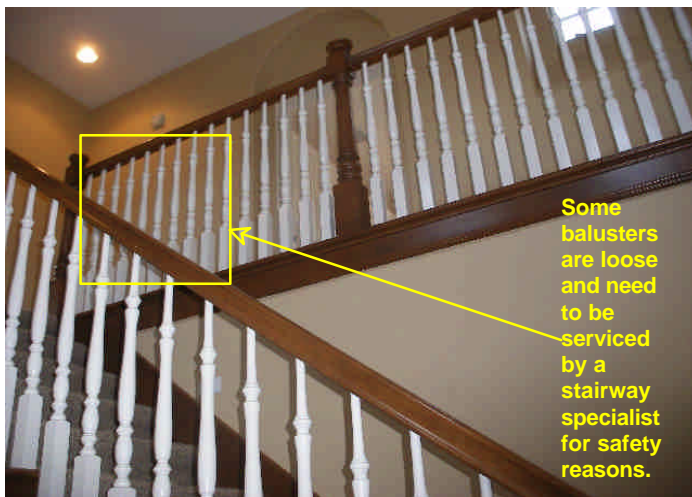
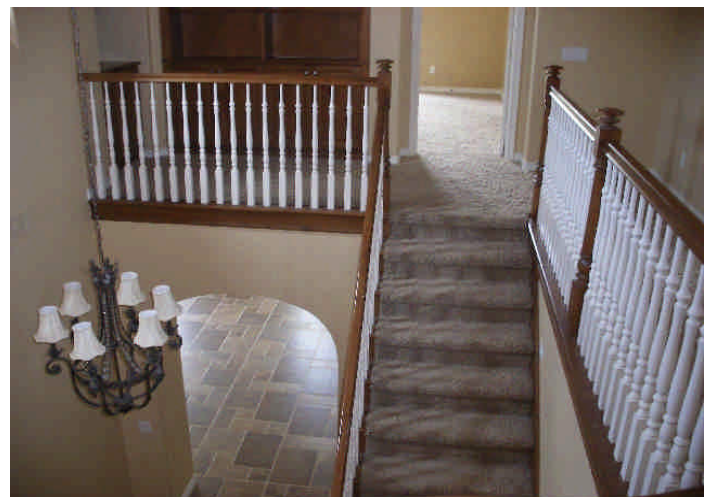
Some balusters in the stair rails and guardrails are loose or damaged and should be serviced. Some balusters are not secure and need service by a specialist for safety reasons.

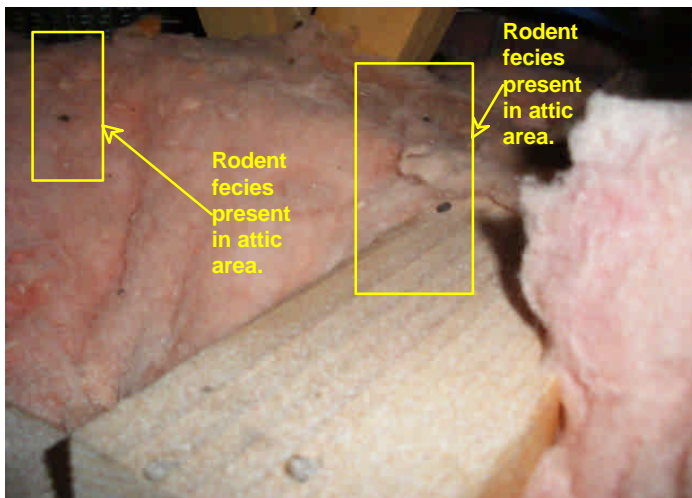
The attic is contaminated by rodents, which is a significant health hazard, and should be evaluated by an exterminator as soon as possible. Rodents can compromise not only the attic and its various components, such as ducts and insulation, but can eventually compromise the living space as well. Consequently, we disclaim any further responsibility for evaluating the attic and its components.

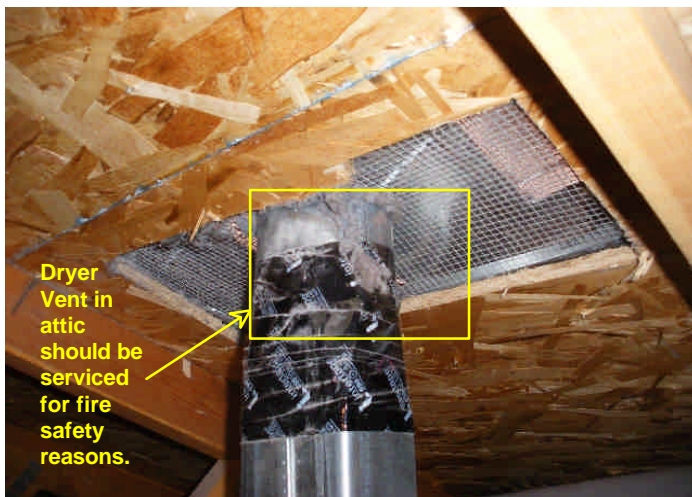
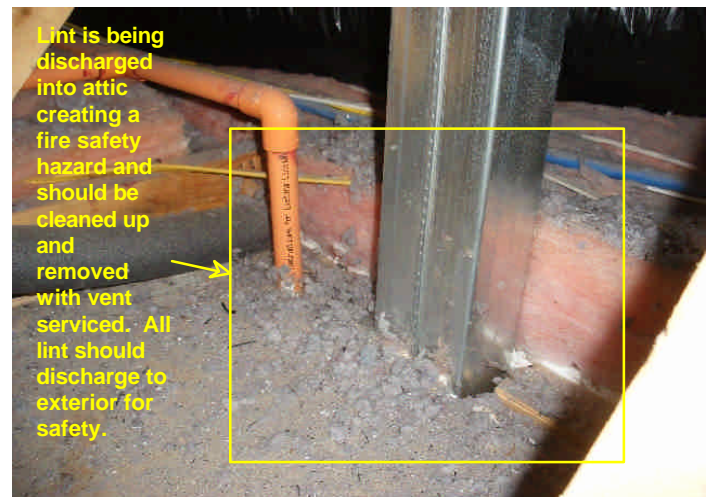
The vertical dryer vent in attic should be cleaned and serviced for fire safety reasons. There is lint present in the attic, and this could create a possible fire safety hazard since the vent may be obstructed. This condition should be serviced by a licensed specialist, and the lint removed from the attic.

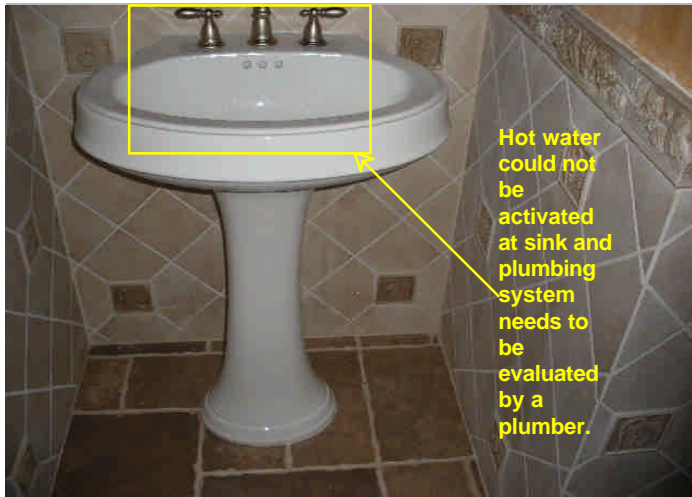
Hot water could not be activated at the sink and should be serviced by a licensed plumber. (See comments in plumbing section regarding hot water heater and expansion tank) regarding bathrooms.

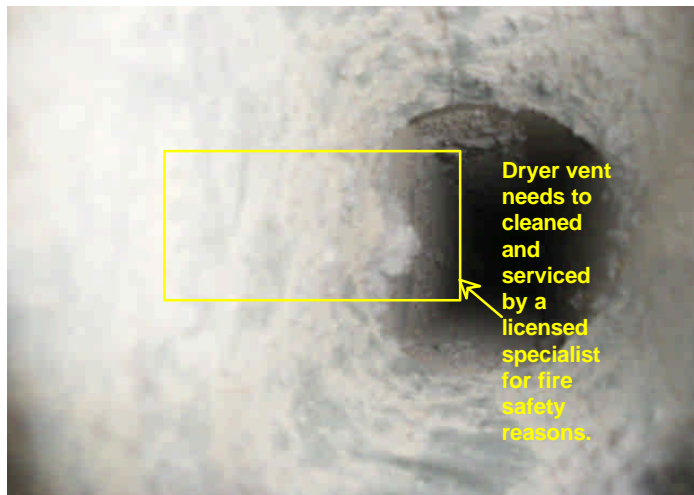
Faulty dryer vents have been responsible for thousands of fires, hundreds of injuries, and even deaths. The best vents are a smooth-walled metal type that travels a short distance; all other types should be regarded as suspect, and should be inspected bi-annually to ensure that they do not contain trapped lint or moisture. The dryer vents vertically and needs service by a licensed specialist for fire safety reasons. The lint trap must be kept clean, because trapped lint can rapidly turn into a fire hazard. (Also see discharge of lint in attic) under the Attic Section of report.

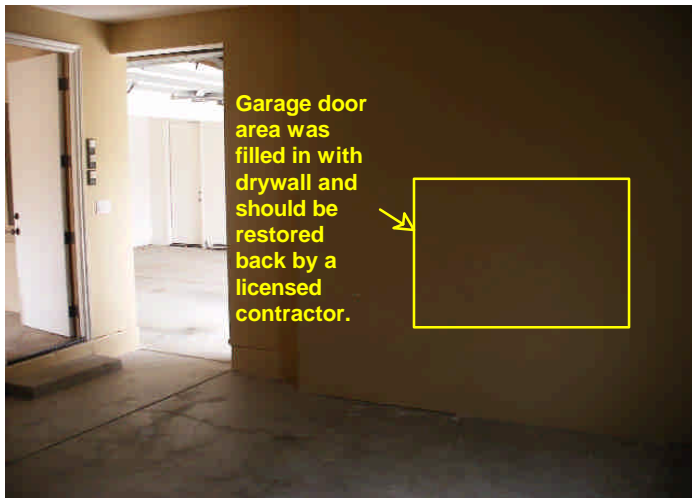
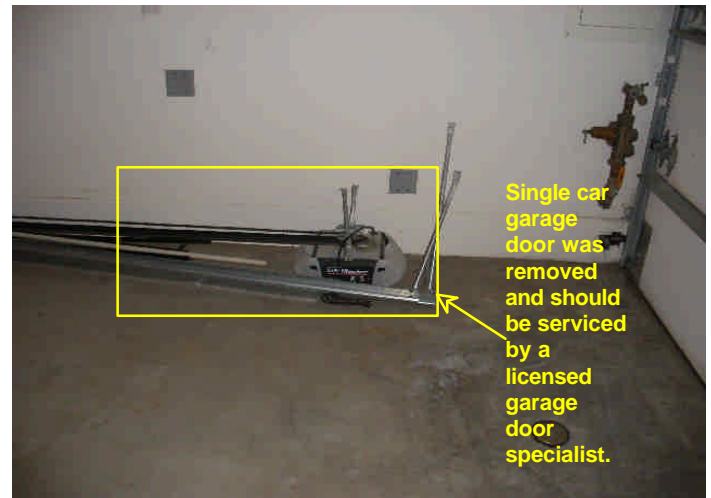
The single car garage door area was filled in with drywall, with the garage door opener removed. The garage should be restored by a licensed contractor back to its original designed use intended for vehicle storage. This is important because our inspection does not tacitly approve, endorse, or guarantee the integrity of any work that was done without a permit, and latent defects may exist.

A garage space has been converted and should be restored to its original condition by a contractor, the space should be converted back to a functional parking space for vehicles.
